**2015 AHERA THREE-YEAR
RE-INSPECTION REPORT FOR THE
DERBY PUBLIC SCHOOLS**

Derby Board of Education
Derby, Connecticut

TRC Environmental Corporation
Windsor, Connecticut

August 2015

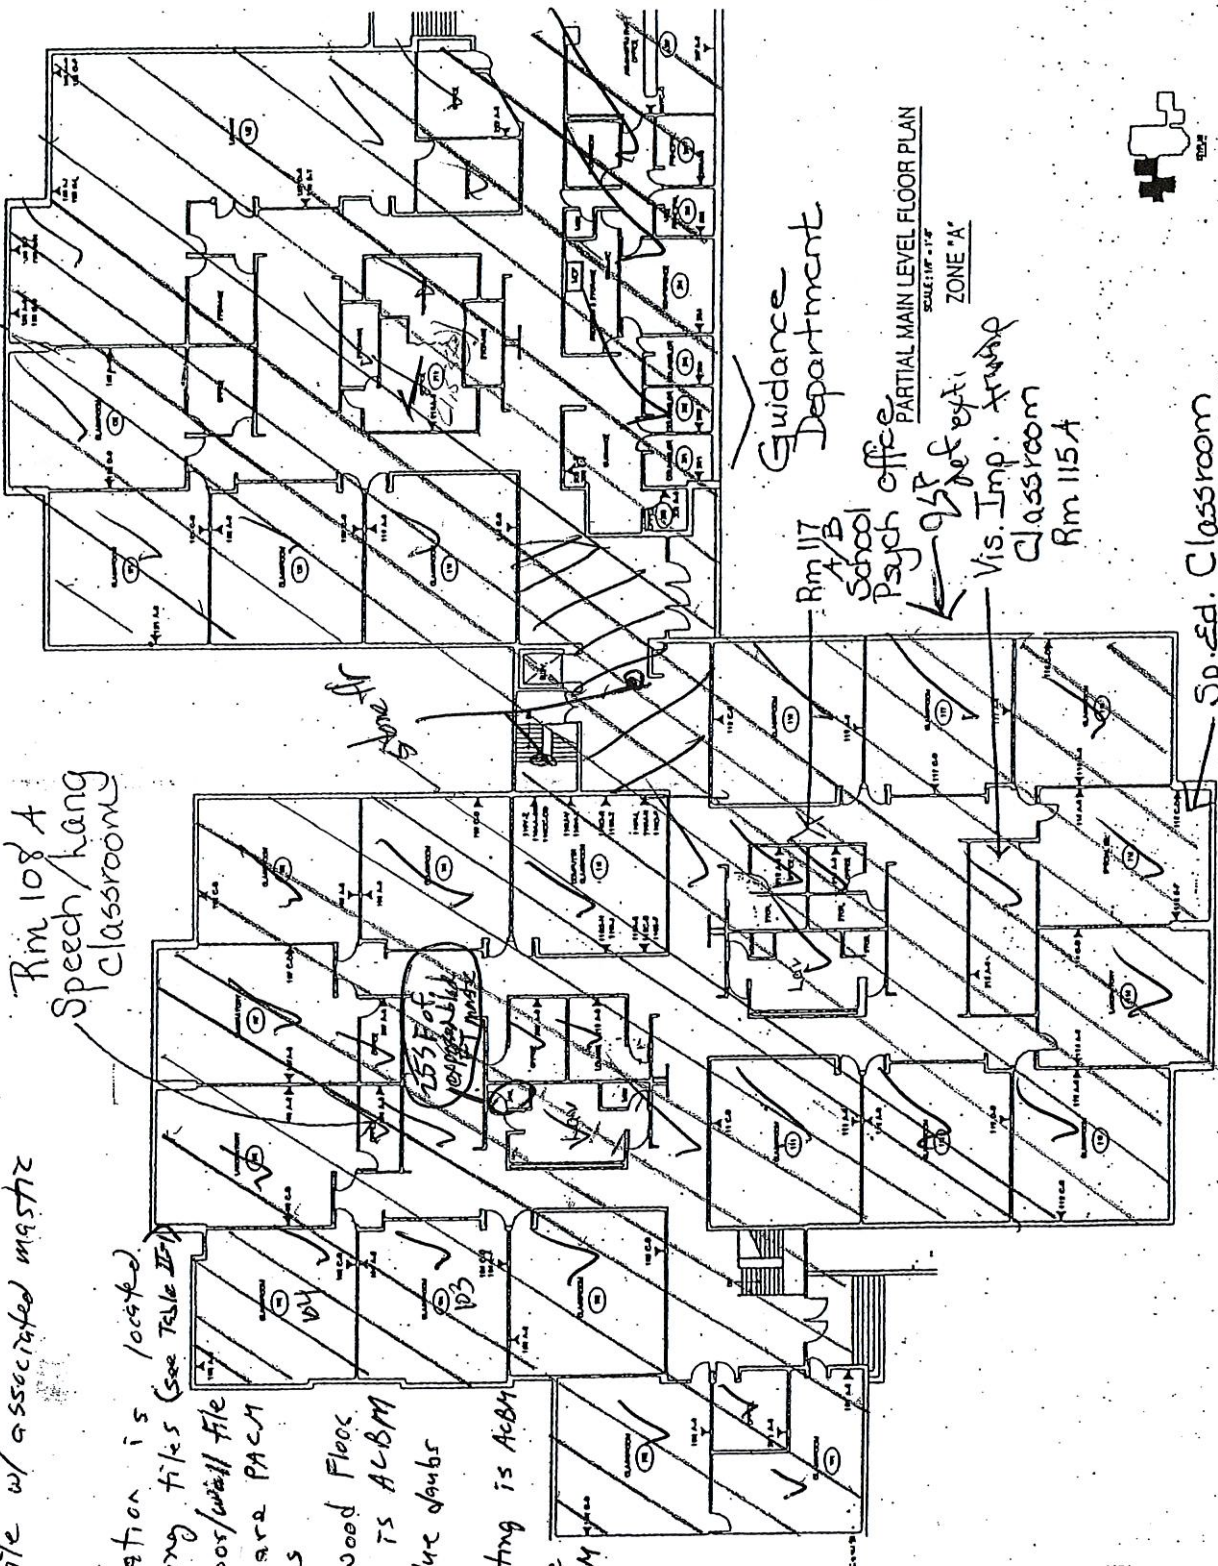
PARTIAL MAIN LEVEL FLOOR PLAN
SCALE: 1/4" = 1'-0"
ZONE "A"

- 2) ceramic floor/wall tile adhesives are PACM in restrooms
- 3) Glue under wood floors in wood shop is ACBM
- 4) Black board glue doubler are ACBM
- 5) sink undercoating is ACBM
- 6) gray cove base w/ master is ACBM

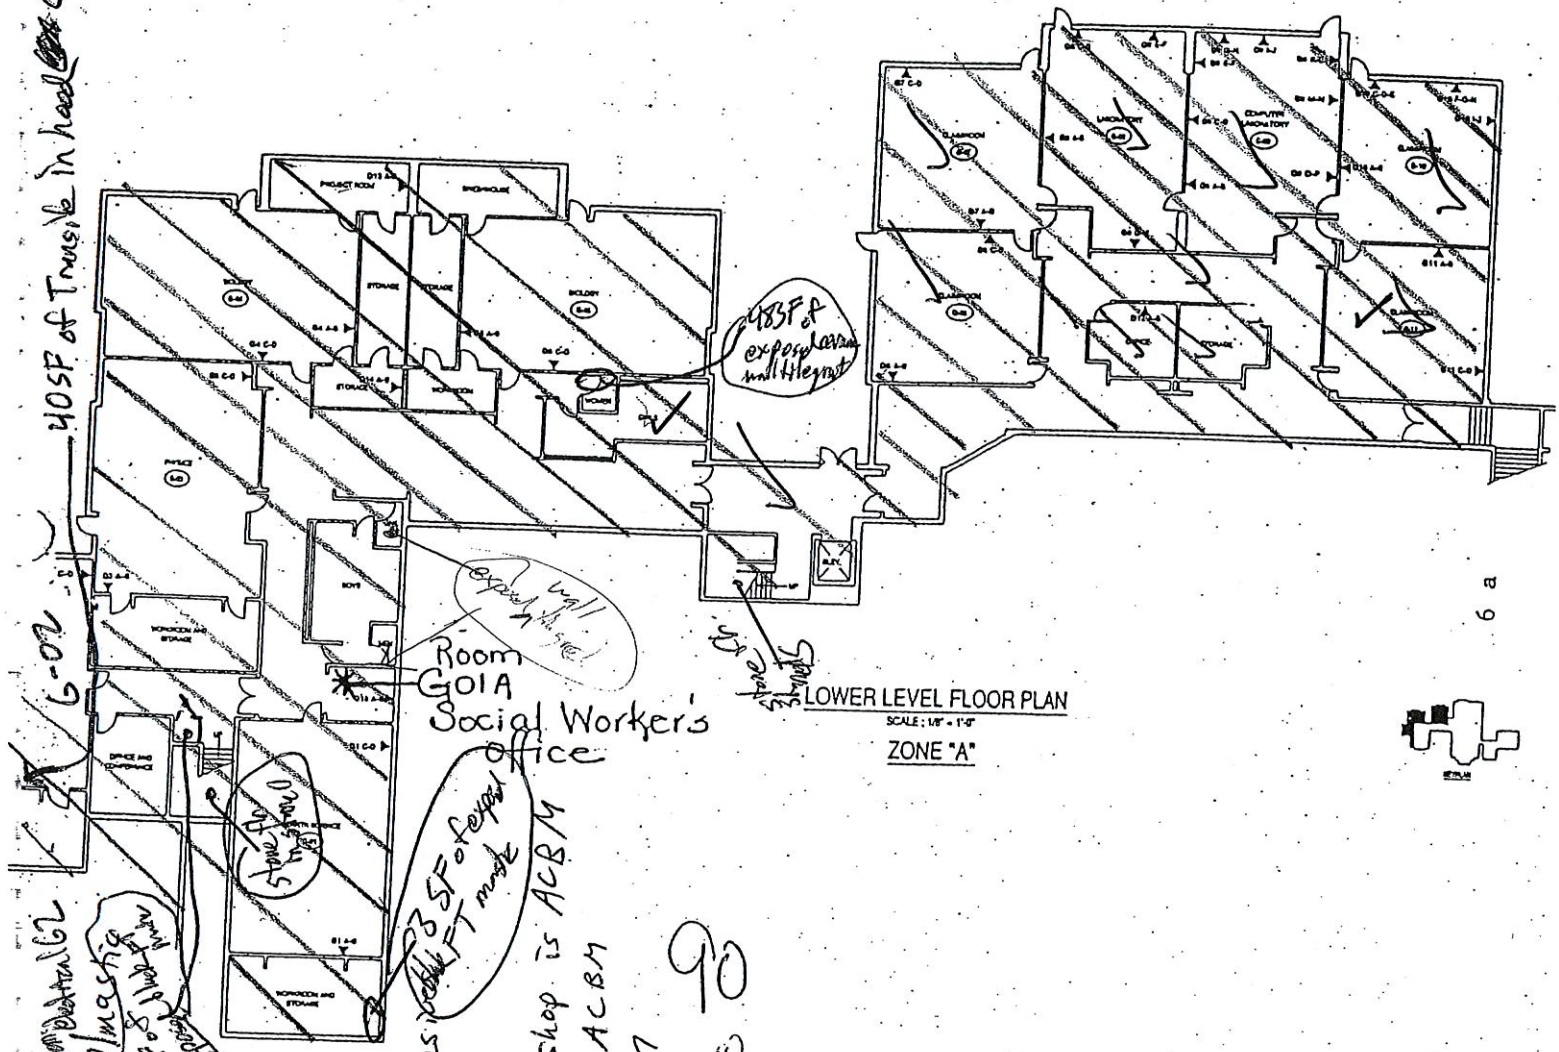
LOWER LEVEL FLOOR PLAN
SCALE: 1/8" = 1'-0"
ZONE "A"

40SF of Truss in head of Contact - exposed obj

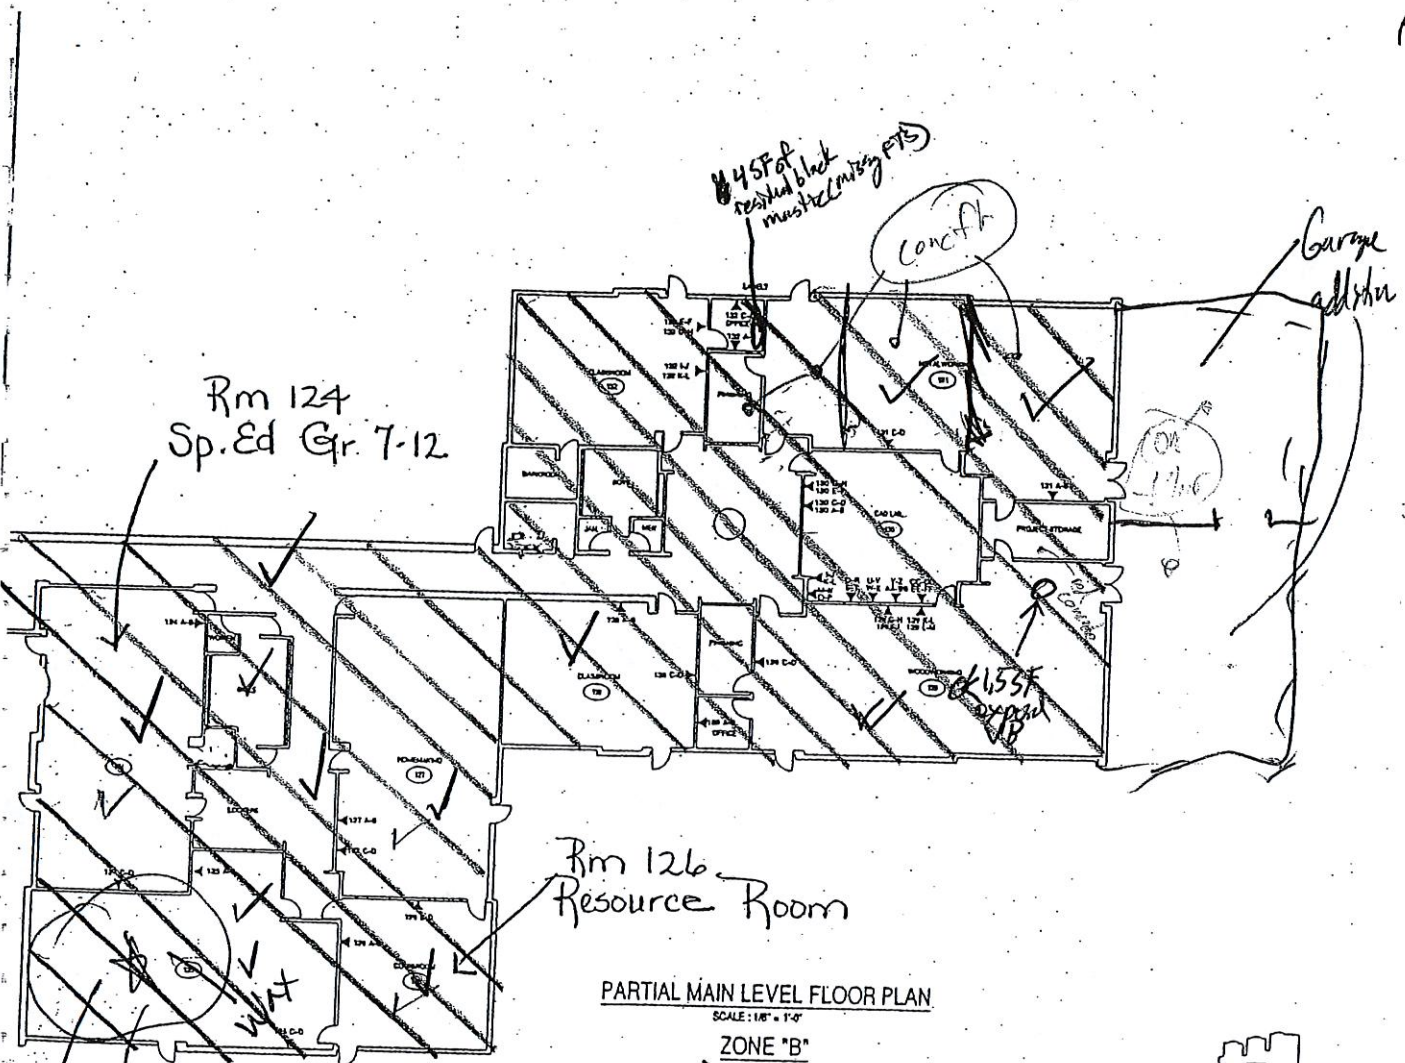
PARTIAL MAIN LEVEL FLOOR PLAN
SCALE: 1/8" = 1'-0"
ZONE "B"

- 1) pipe insulation is located above ceiling tiles (see Table II-1)
- 2) ceramic floor/wall tile adhesives are PACM in restrooms
- 3) glue under wood floor in wood shop is ACBM
- 4) Blackboard glue dams are ACBM
- 5) sink undercoating is ACBM
- 6) gray core base w/ mastic is ACBM

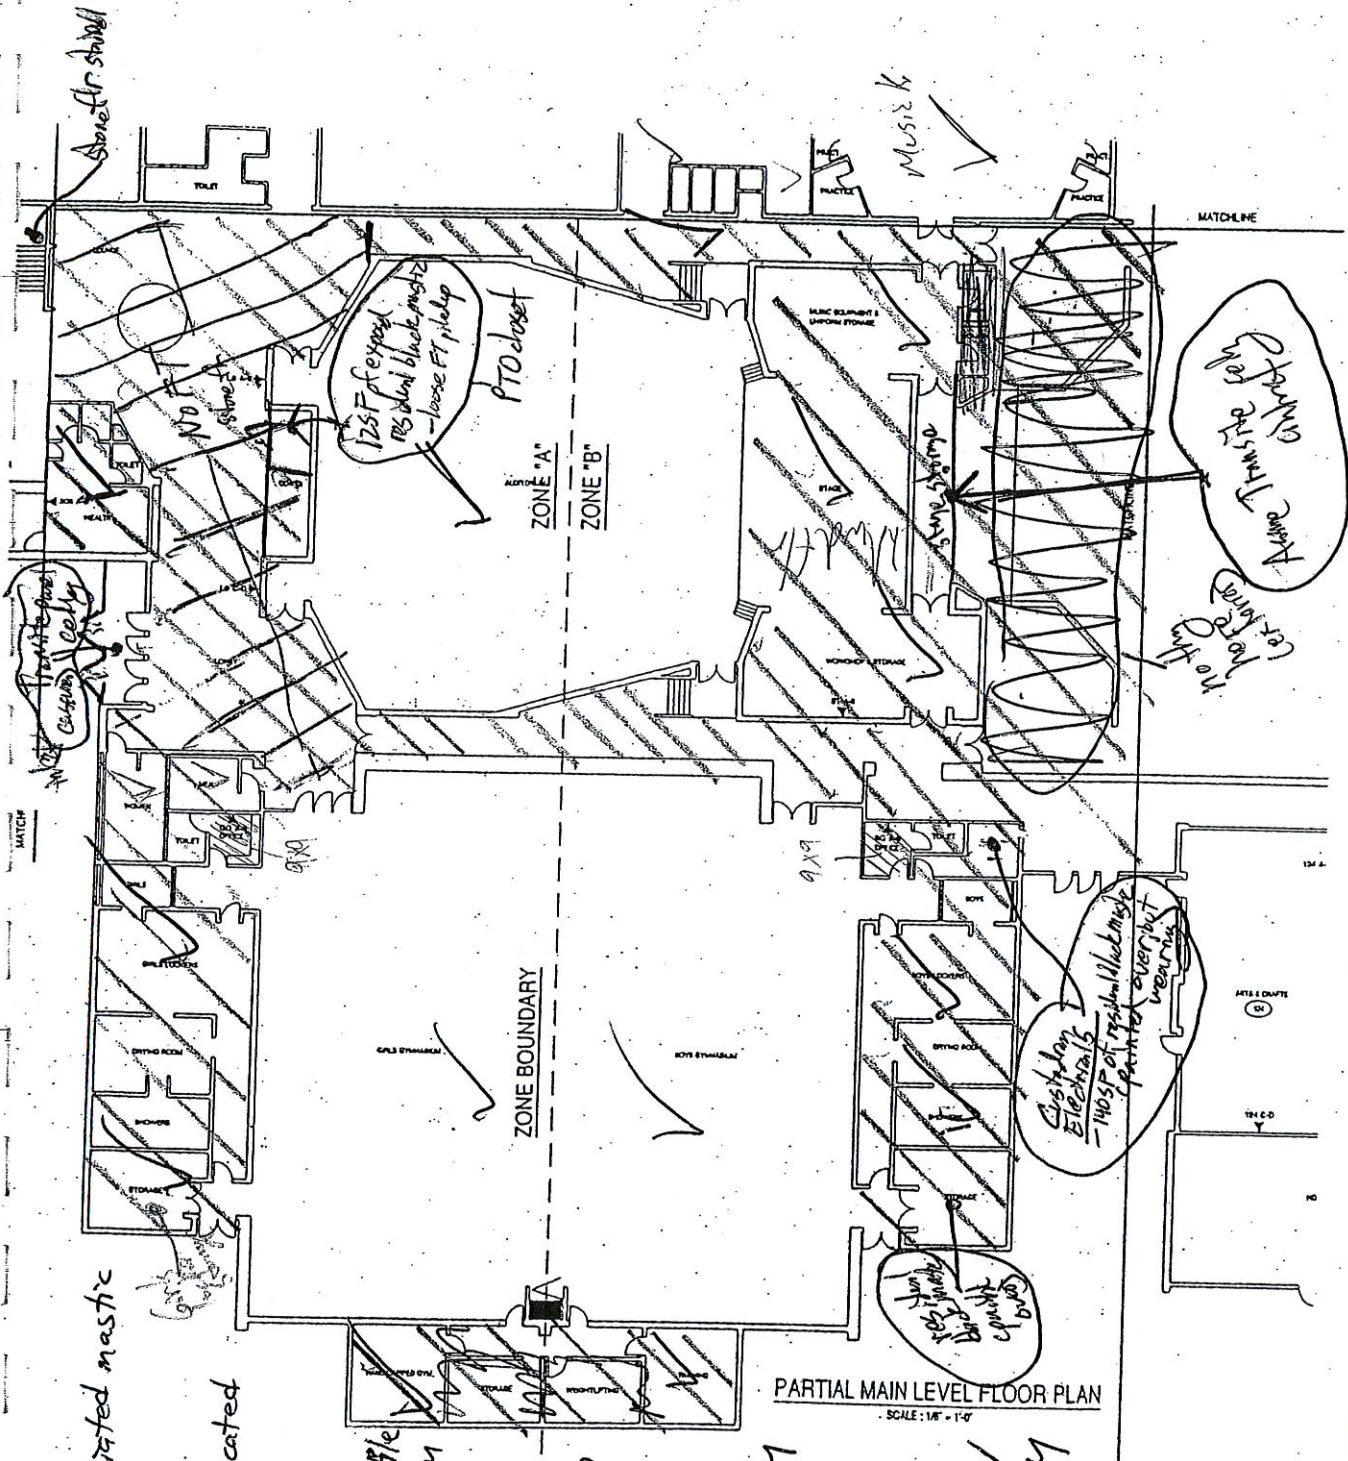
PARTIAL MAIN LEVEL FLOOR PLAN
SCALE: 1/8" = 1'-0"

- 1) Pipe insulation is located above ceiling tiles (See Table II-1)
- 2) Ceramic floor/wall tile adhesives are PACM in restrooms
- 3) glue under wood floor in wood shop is ACBM
- 4) Blackboard glue daubs are ACBM
- 5) sink undercoating is ACBM
- 6) gray cove base w/ mastic is AEBM

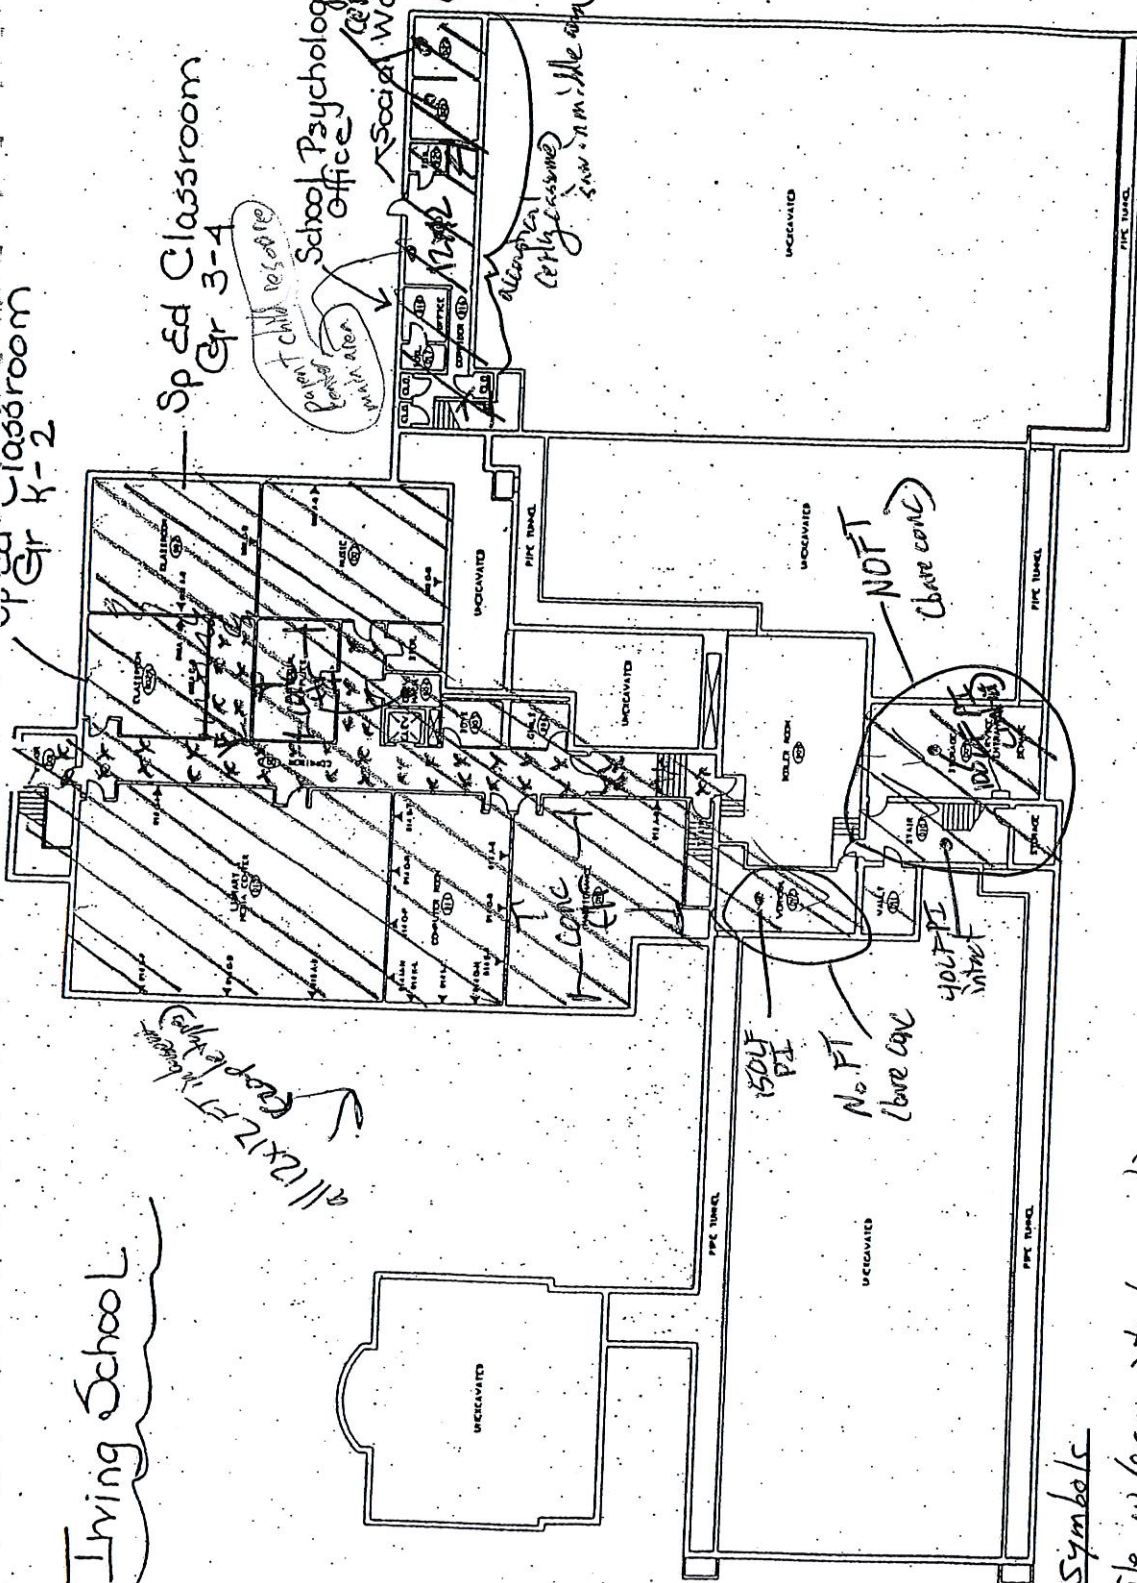
LOWER LEVEL FLOOR PLAN
SCALE: 1/8" = 1'-0"

all 12x12 FT in concrete
(except for)

- 1) Pipe insulation is located in the Boiler Rm, in tunnels, and above ceiling tiles.
- 2) Ceramic floor tile adhesives are PACM, stair tread glue TS ACBM.
- 3) See Table II-2

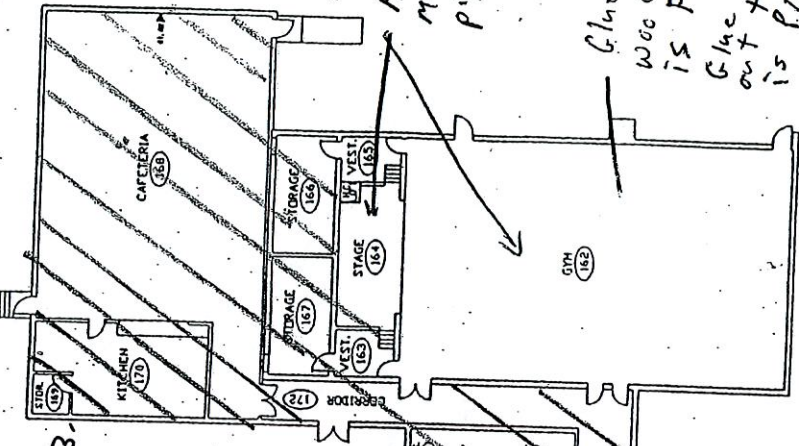
- Roof Flashing / fan sealants is PACM
- HUAC Flex connectors are ACM
- see Table II-3.

ACM
 Mudded pipe fittings

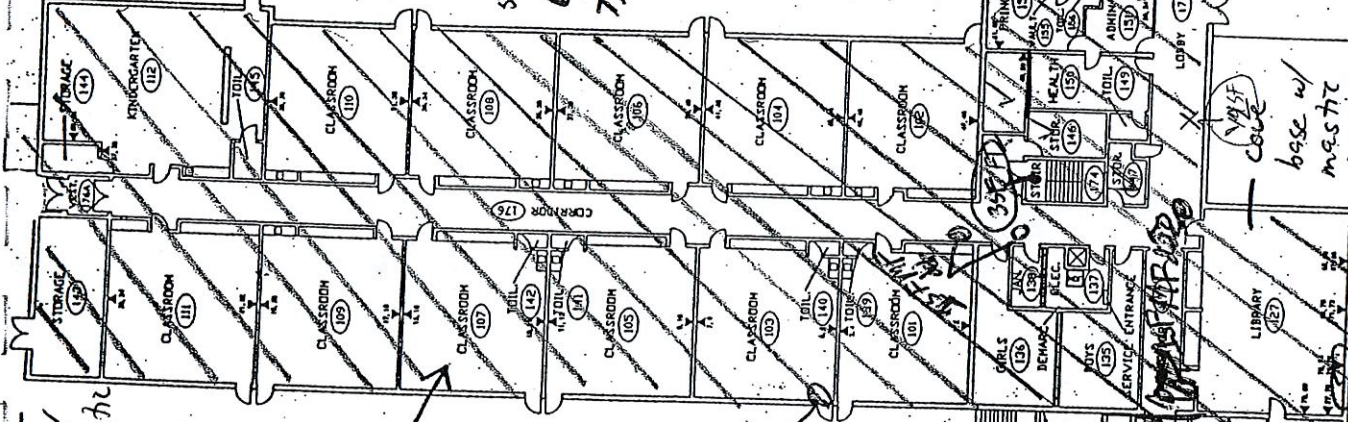
Glue under wood floor is PACM
 Glue on pull out table top is PACM

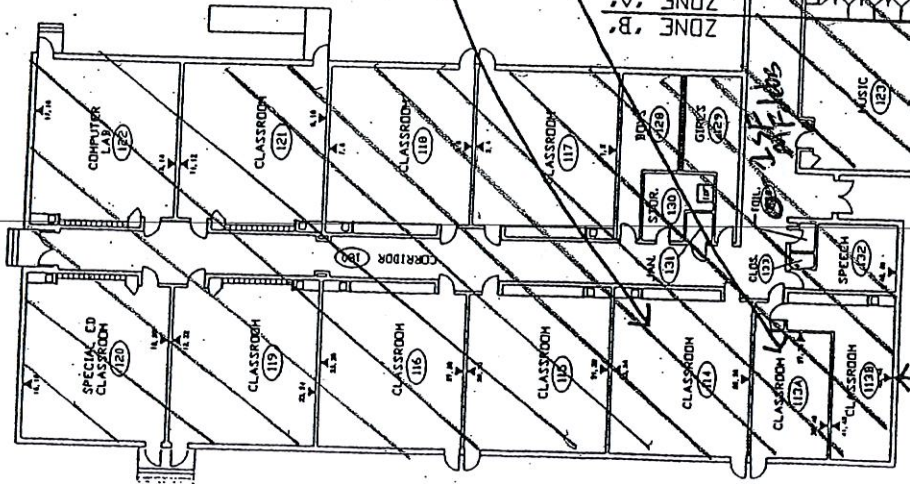
Social Worker's office when Art not scheduled
 residual glue in library

base w/ mesh is ACM in library
